**FIVE-YEAR REVIEW
FINAL REPORT**

**FLOWOOD SUPERFUND SITE
FLOWOOD, RANKIN COUNTY, MISSISSIPPI**

MARCH 1998

**Roy F. Weston, Inc.
Suite 200
5405 Metric Place
Norcross, Georgia 30092**

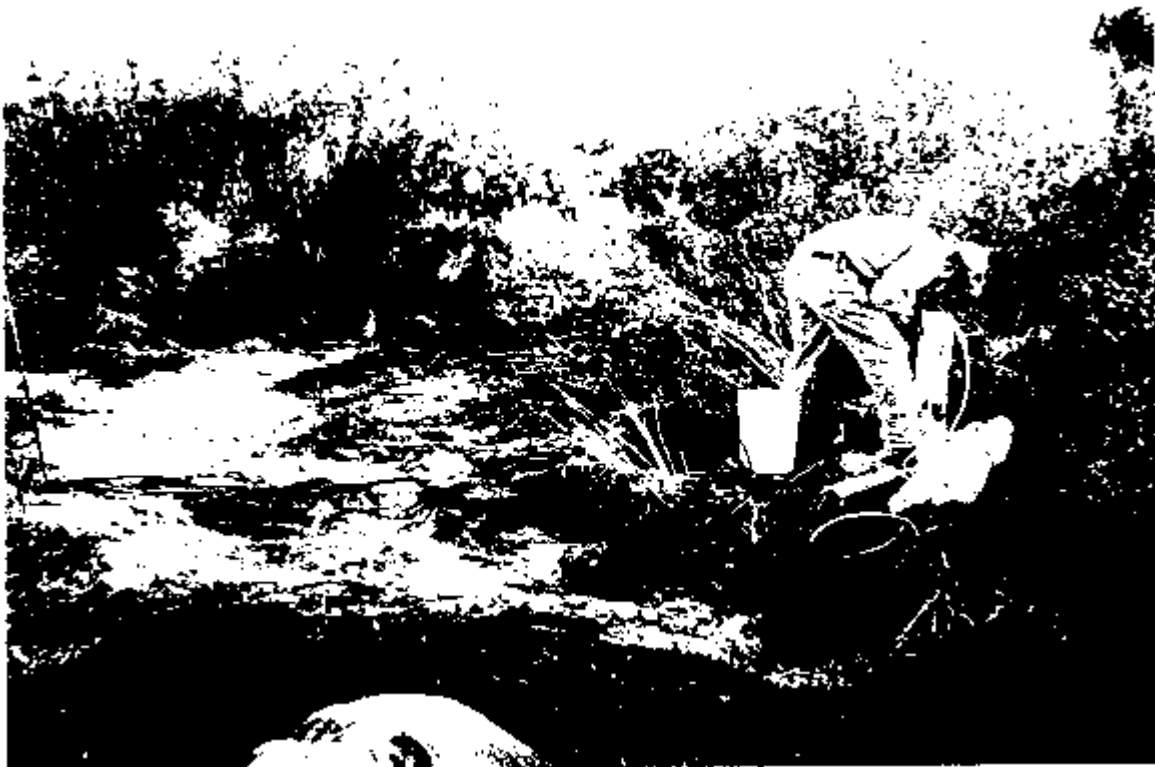
Photograph No. 3

Description: PRP contractor purging well MW-17 in preparation for sampling. This well is located northeast of the MPA adjacent to a bituminous concrete plant operation. Oily, dark residue from this plant was observed in the soil around the well.

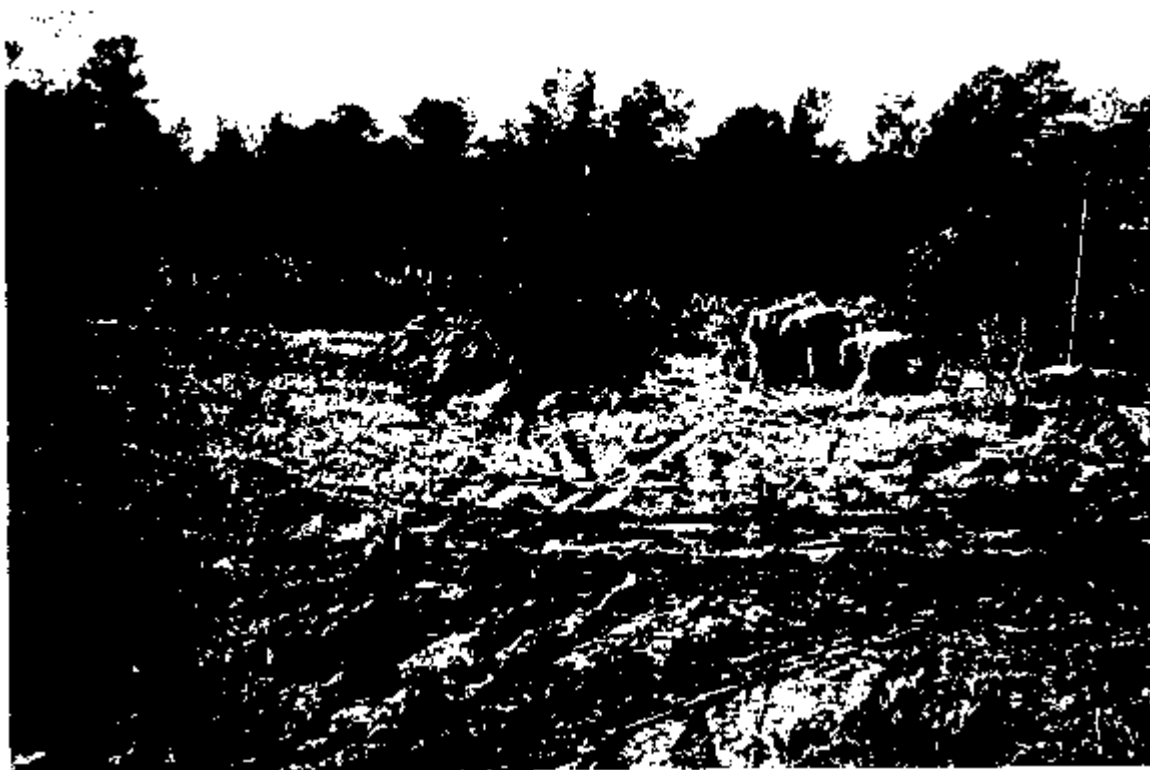
Photograph No. 6

Description: Topsoil and hay bales staged adjacent to the MPA for use in repairing eroded areas on the MPA.

the firm that performs the erosion monitoring and also performs the grass mowing, reseeding, and fertilization as necessary. A stockpile of topsoil and hay bales had been staged adjacent to the MPA by Singley to make repairs to the bare soil areas noted during the site inspection.

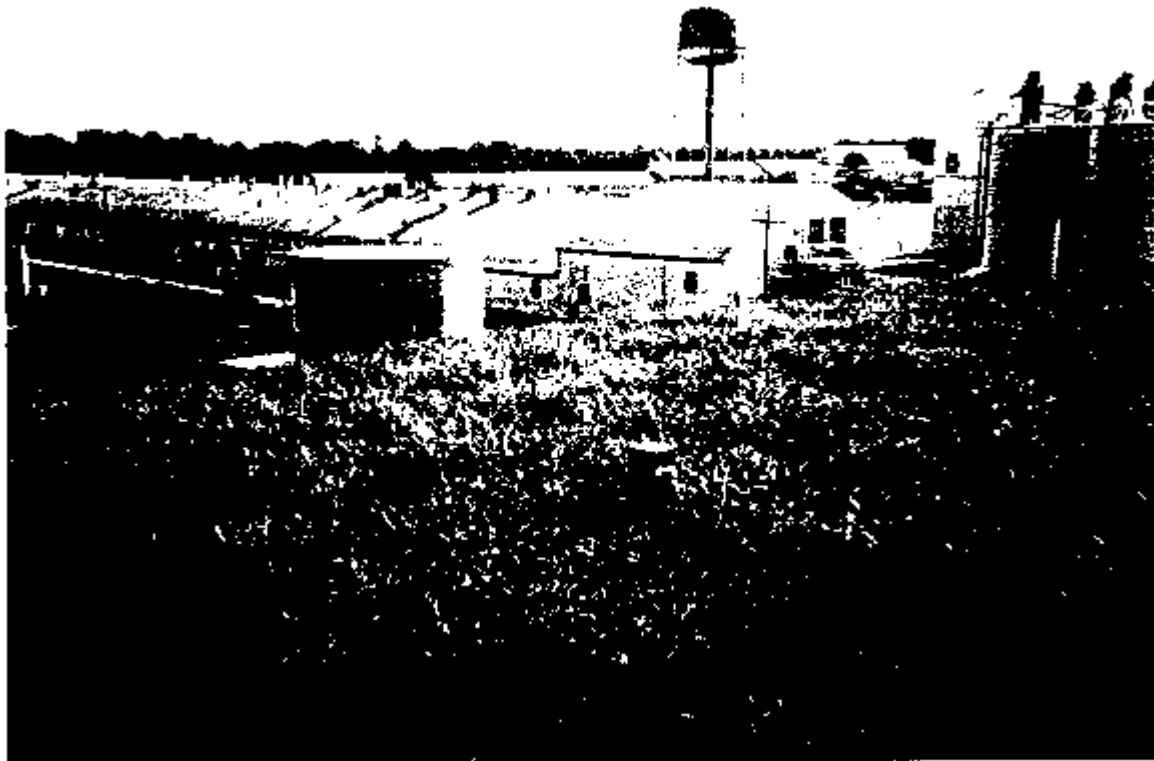
Photograph No. 7

Description: View of well MW-18 on top of the MPA in the foreground and the Rival Manufacturing Plant in the background.

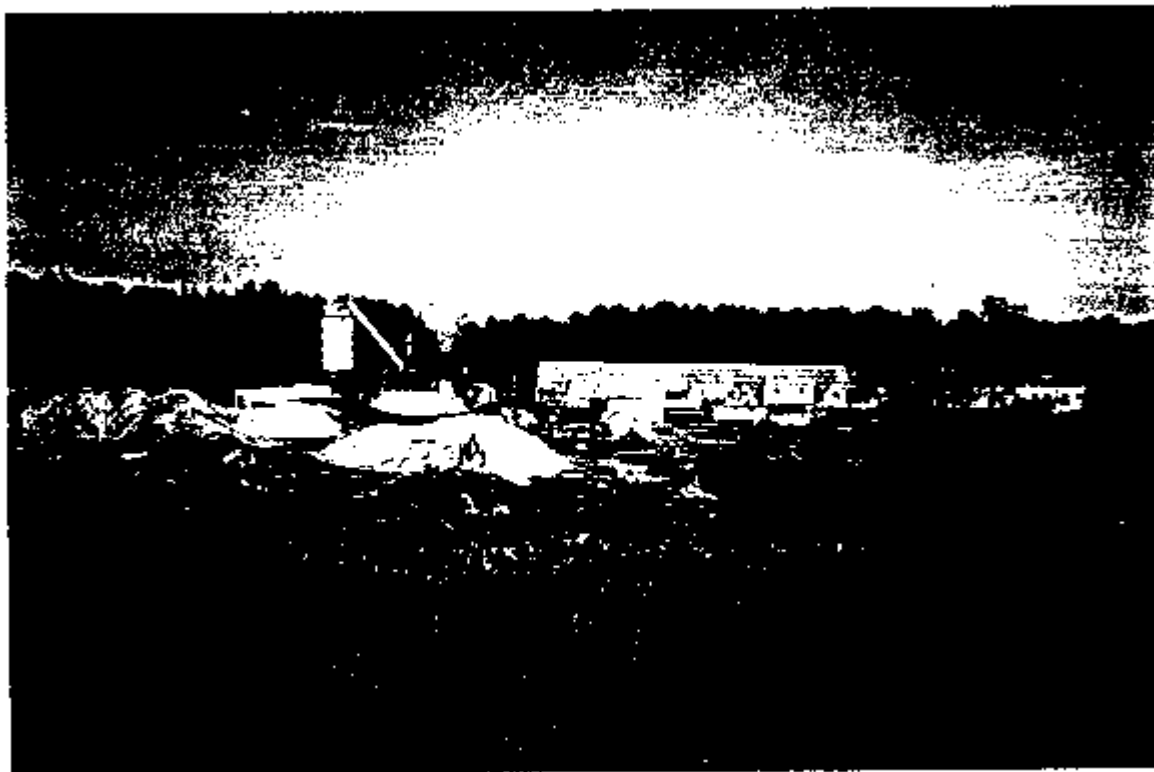
Photograph No. 8

Description: View looking north of the MPA showing the active bituminous concrete plant in the background.
